ANALYSIS OF LEADING EDGE AND TRAILING EDGE COVER GLASS SAMPLES
BEFORE AND AFTER TREATMENT WITH ADVANCED SATELLITE
CONTAMINATION REMOVAL TECHNIQUES

S.P. Hotelling

Rome Laboratory, OCPC
Griffiss Air Force Base, New York 13441-5700

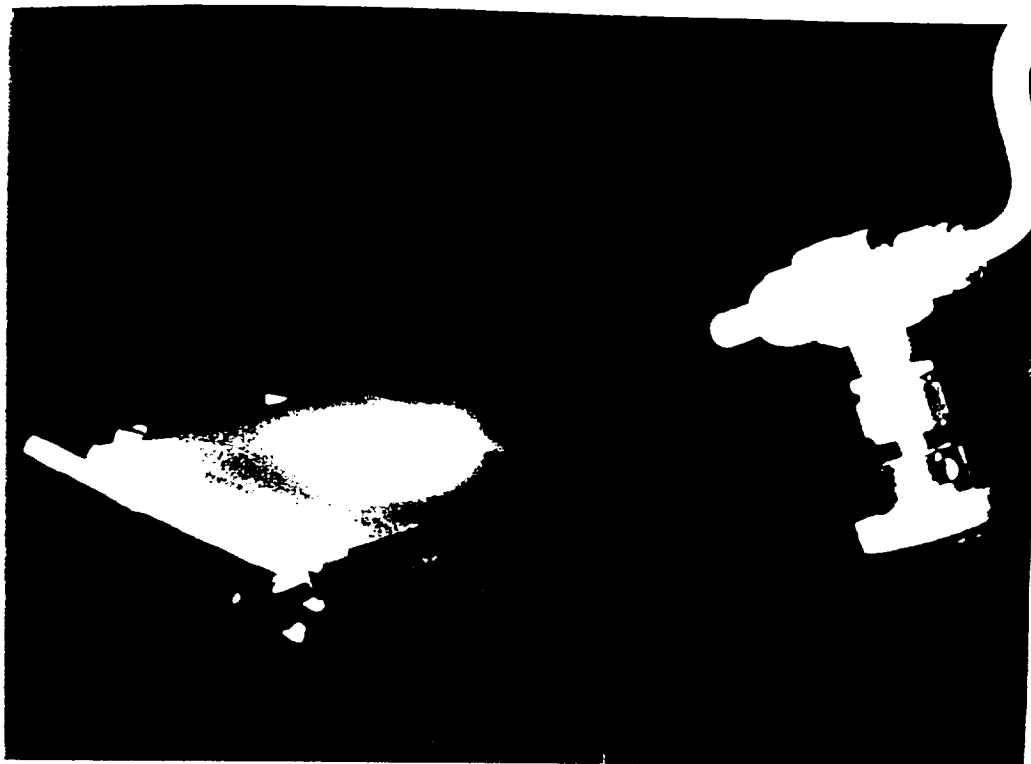
Figure 9. A 35-mm photograph of a research model CO₂ gas/solid jet spray in operation. Newer designs are much smaller and more compact. Flight units have been designed and are awaiting production.

The gas/solid jet spray was used to remove particulate contamination. The CO₂ jet spray is shown in Figure 9. The jet spray has been described in the literature (ref. 1, 2), but may be simply described as a particle removal process which exploits momentum transfer from incident snow flakes to particulates adhering to the surface through van der Waal's forces (first and second order). The energy/momentum transferred to the adhered particle breaks these surface potential forces, and the "free" particle is entrained in the gas stream and carried away from the surface. The mixture of solid/gas in this process is very important for the removal of submicron particles (ref. 1), which are not removed by high pressure gas and liquid streams due to the gas/surface boundary layer's "insulating" action.
